Phase I Environmental Site Assessment
38-40 Camden Street, Toronto, ON

Project 19*4563 BRUCE A. BROWN ASSOCIATES LIMITED
Consultants in the Environmental & Applied Earth Sciences

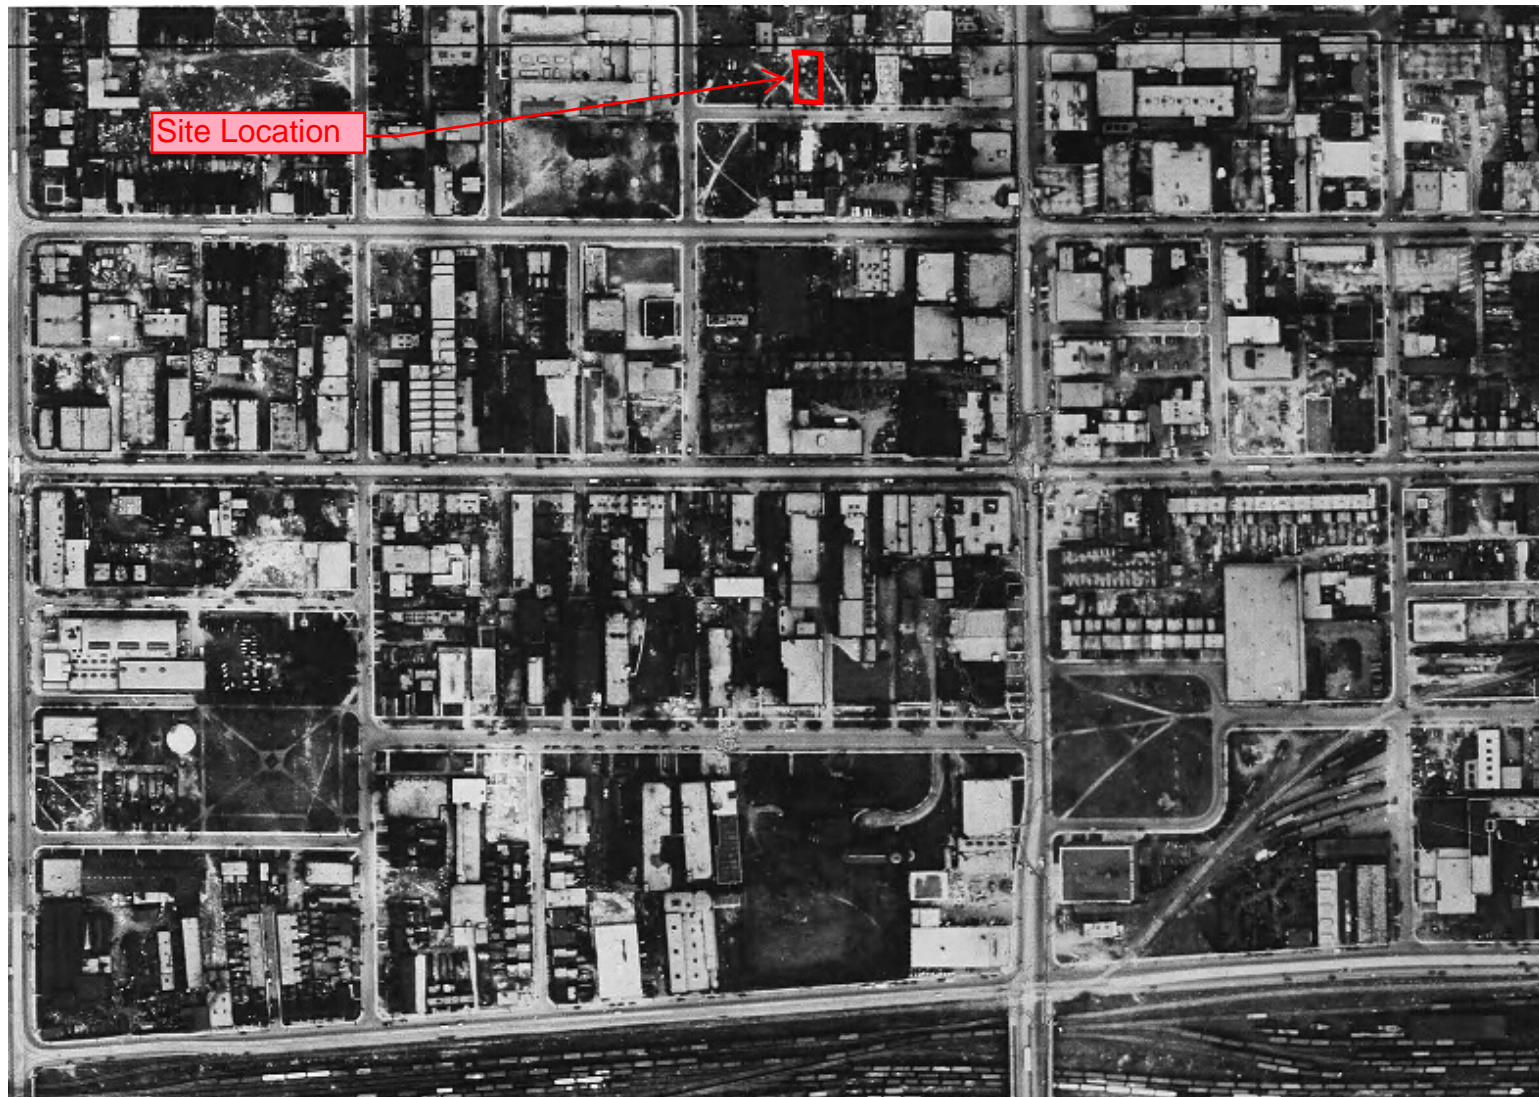
Historical Air Photo: 1947

Historic air photos, attached in **Appendix C**, include photographs from the Toronto Archives Library between the years 1947 to 1992, as well as more recent photographs from Google Earth for the years 2004 and 2018. The earliest air photo from 1947 shows the site as vacant with several parked cars, together with vacant parking lots on both sides and to the north. A single commercial building is surrounded by vehicle parking on the south side of Camden. By 1950 new buildings are constructed on both sides of 38-40 Camden with no changes noted on the south sides of Richmond or Camden, while the Phase One property has about 18 cars parked on it.
